Windows 10 and the GoZone Device

October 28th, 2016

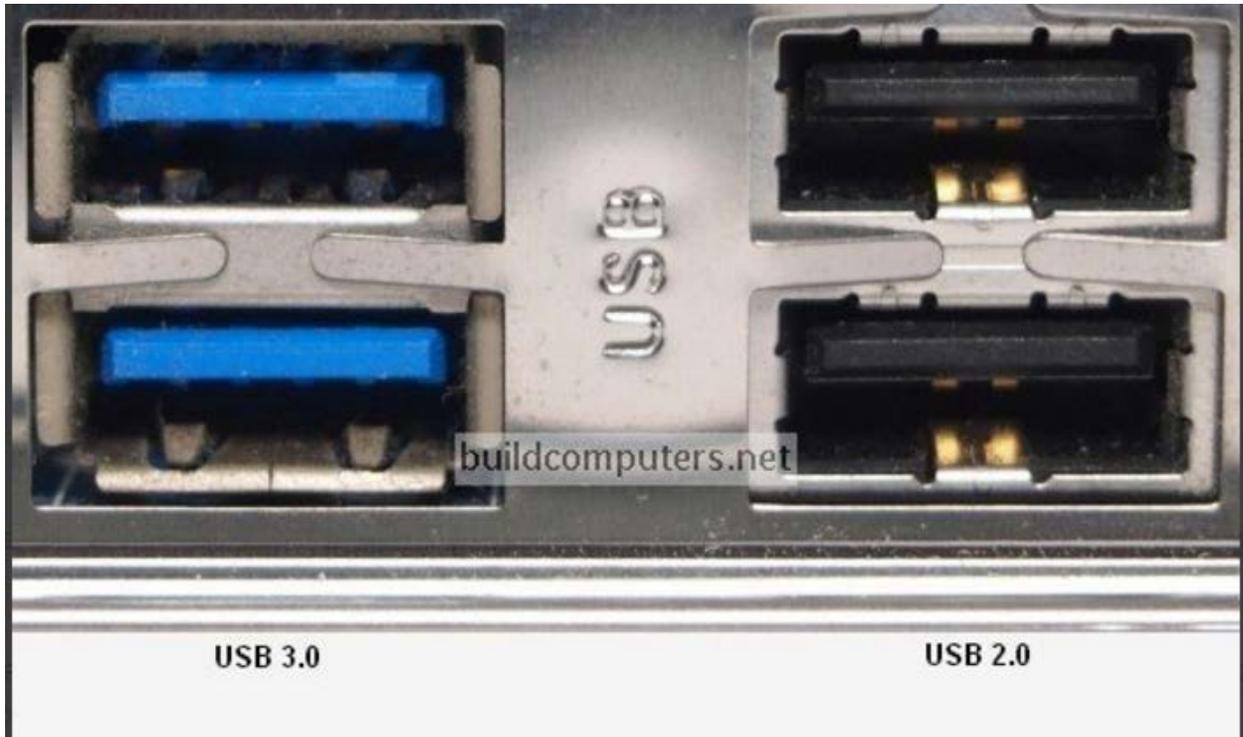
The first issue is that the drivers for your USB ports may need to be reconfigured or reinstalled. This is only valid for Windows 10 computers that have **USB 2.0** ports (these ports will look like those seen on the right side in the picture below. USB 2.0 ports may also have white plastic insides, instead of black).

The second issue that can arise is if your Windows 10 computer comes equipped with **ONLY USB 3.0** ports. These ports will look like those on left in the image above, and will always be blue. Unfortunately, you will not be able to sync your GoZone with this type of port. However, there is a workaround which has been successful for members that only have USB 3.0 ports. If you purchase (or you may already have) an inexpensive USB hub, *it will effectively convert your USB 3.0 back down to USB 2.0*. Please see the image below for an example. Then, you will be able to sync your GoZone with your Windows 10 computer.

If your GoZone is not working with your Windows 10 computer and you have USB 2.0 ports, please try the following for troubleshooting: [How to Sync Your GoZone with Windows 10](#)
